# Chemical Mechanical Polishing to Create Pure Ge-filled trenches within Silicon Dioxide

CMP Process : M. Smalley

Epitaxial Process : D. Franca, T. Adam

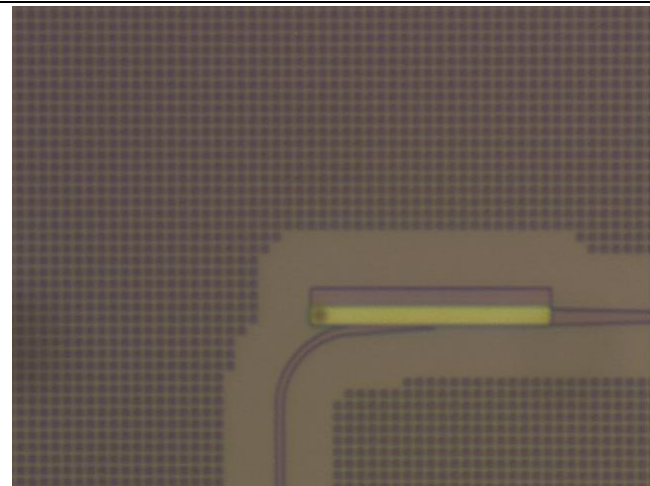
## Slot 6 – Fujibo pad (soft) at 2psi + 30s

Under Polish

4 Day Growth

Queue time required

- Slot 1 run as control, pull out still observed with 30s 2psi recipe and portions of lines still not clear. Touch up 30s polish run to clear Ge.
- Slot 4 run with Fujibo pad for 60s. Significant dishing present while lines appear to be clear and pull out not visible.
- Slots 5 & 6 run for shorter time splits. Dishing still present while large structures appear to not be clear. Pull out not observed.
- Slot 6 inspected again 4 days after polish and small “growths” observed on predominantly narrow lines.

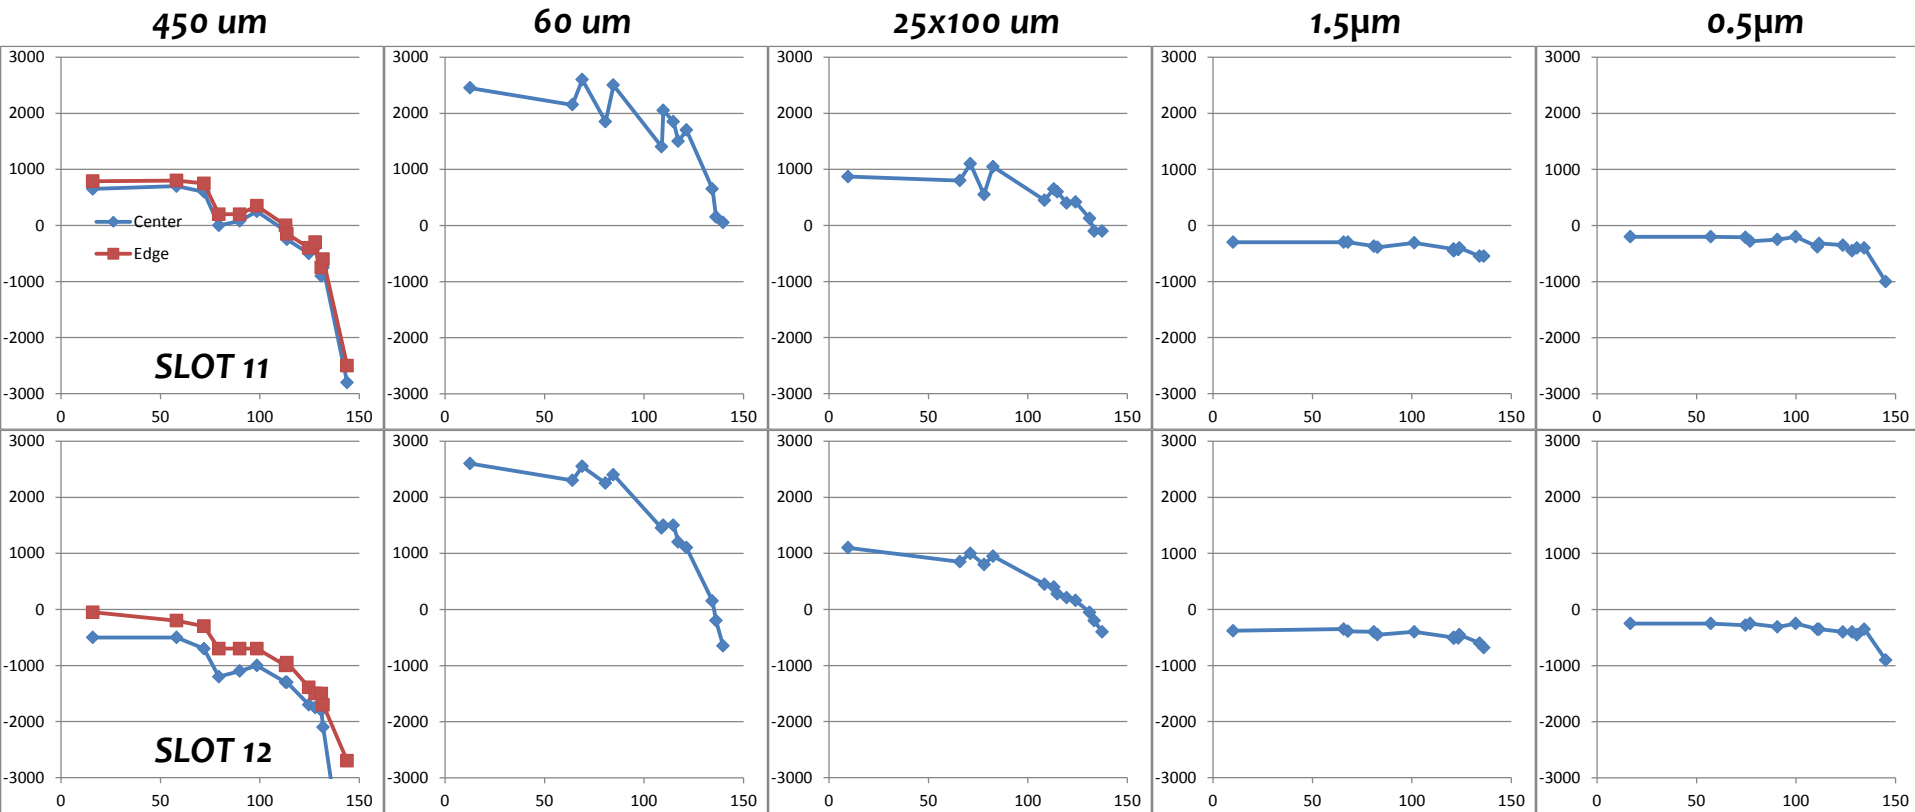
# Step height radial uniformity

Data suggests that smaller isolated structures are “protected” by surrounding oxide. Also suggests that future improvement can be achieved through Epi growth and CMP removal uniformity optimization.
